STRUCTURE NO. 00708

PONUS RIDGE ROAD

ROUTE 15

(In depth)
Supplemental / Special Inspection
on
11/25/2011

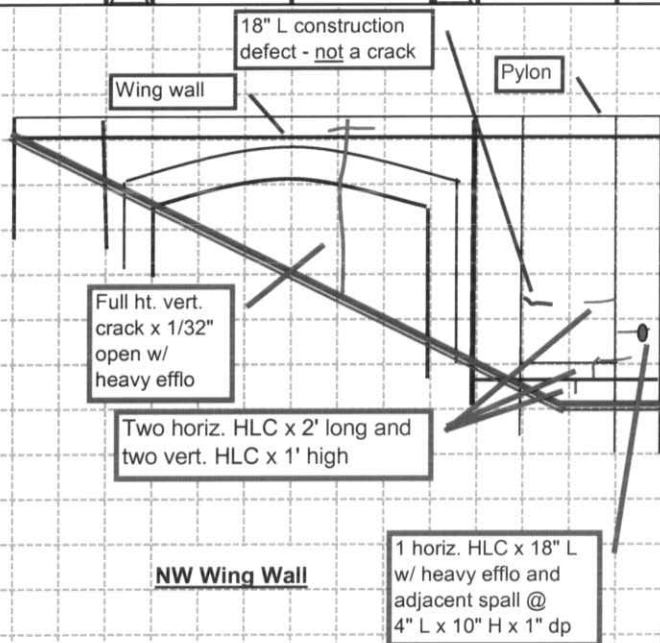
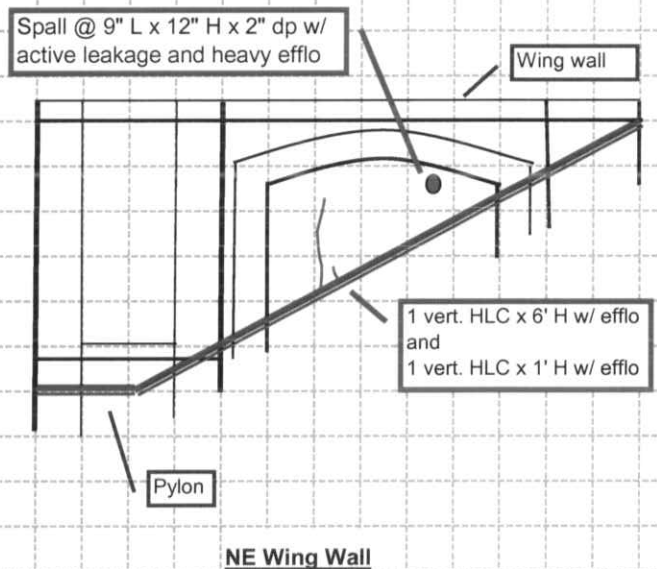
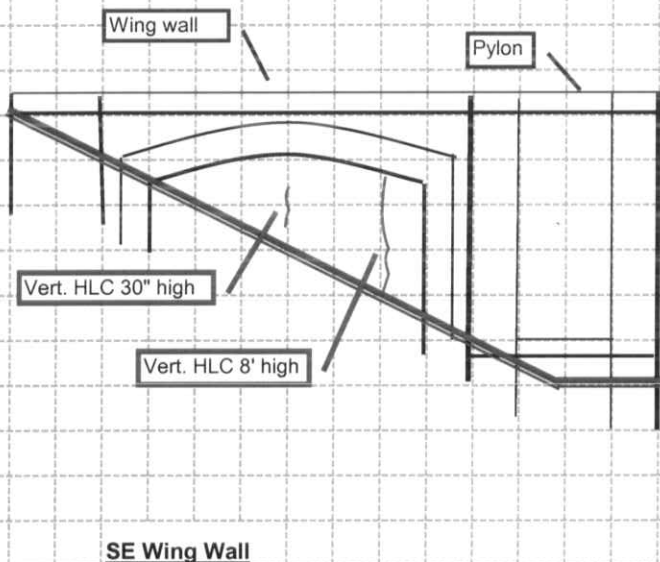
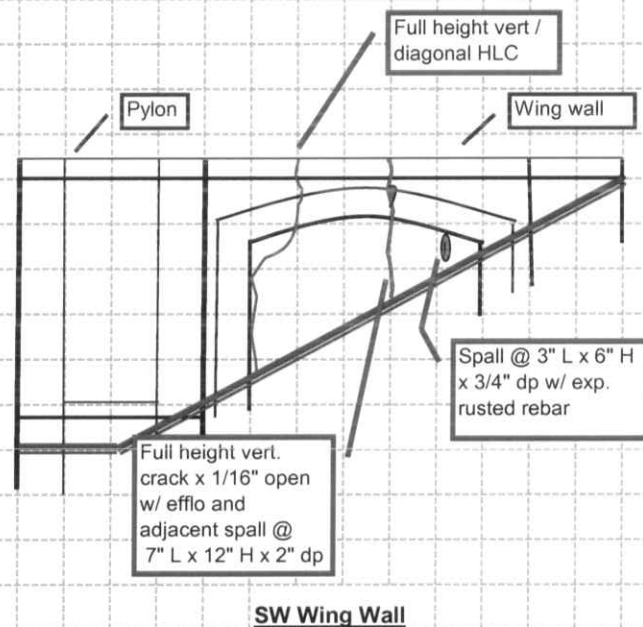
1. All wing walls and pylons show large areas of light scale.
2. All wingwalls show heavy vine growth limiting ability to see areas of deterioration. Access to all wings is limited by heavy growth of vines, brambles and brush immediately adjacent to wing walls.
3. All full height cracks extend across the top of the curb / railbase and down the inside face of the curb.
